The Performance of House Foundations in the Canterbury Earthquakes

Master of Engineering in Civil Engineering

Duncan Henderson

August, 2013

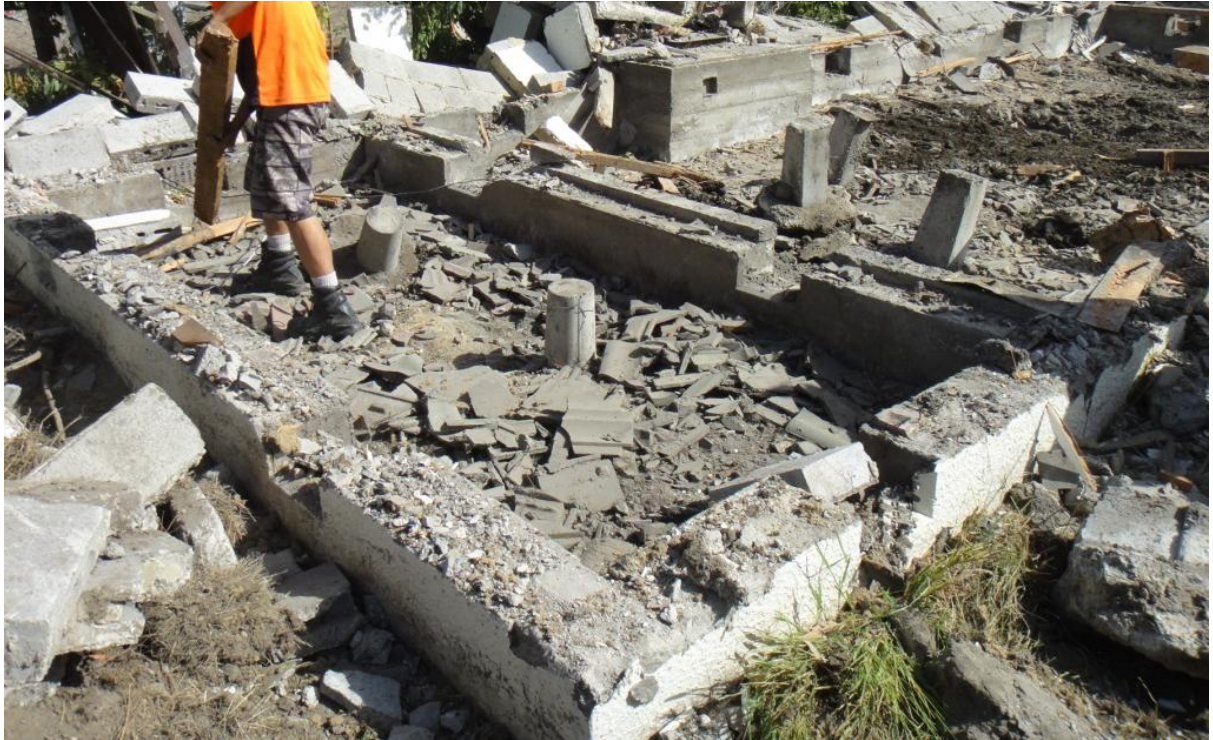
Upon demolition of the house, it was found that this end section was actually an extension to the main house. The perimeter foundation wall was cast up against the old wall, but had no physical attachment (Figure 16). This, combined with the heavy cladding and roofing material, allowed this to break off and settle more than the rest of the house which was better connected together, and hence caused the only significant structural crack in the house, and crack (actually separation) in the perimeter. The old East perimeter wall was no longer carrying any significant load, as this was all transferred to the new perimeter, but was still able to provide significant stiffness to the rest of the main body of the floor, reducing settlement in the original part of the house.

Figure 16. P18: East end section of the house showing separate perimeter.

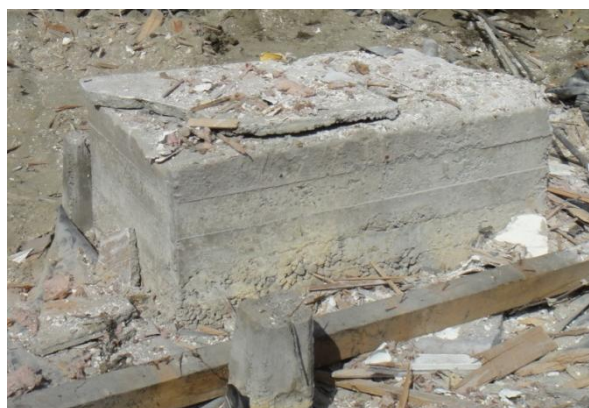
There were three large cast-in-situ concrete footings, shown on the floor plan in Figure 6, and in Figure 7 below. These were assumed to be for old fire places and steps.

Figure 7. P5: Large cast-in-situ concrete footing within floor plan.

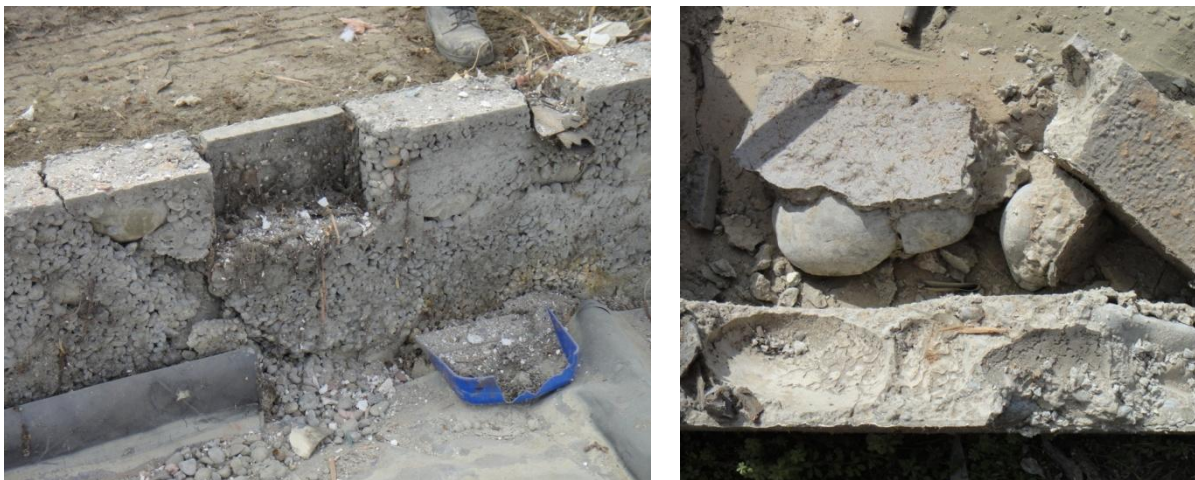
The perimeter was constructed of cast-in-place concrete and was not reinforced. The aggregate was uniformly graded, round stone. The concrete mix was very dry, with lots of aggregate with large gaps around it, particularly on the inside of the perimeter wall. Large stones were used as fill in the bottom of the perimeter wall, up to 200-300mm in diameter. The perimeter broke smoothly and easily around these stones when it was lifted up (Figure 8).

Figure 8. Perimeter details, (left) dry concrete mix showing gaps around aggregate and (right) large stones cast into perimeter as fill, breaking apart cleanly.

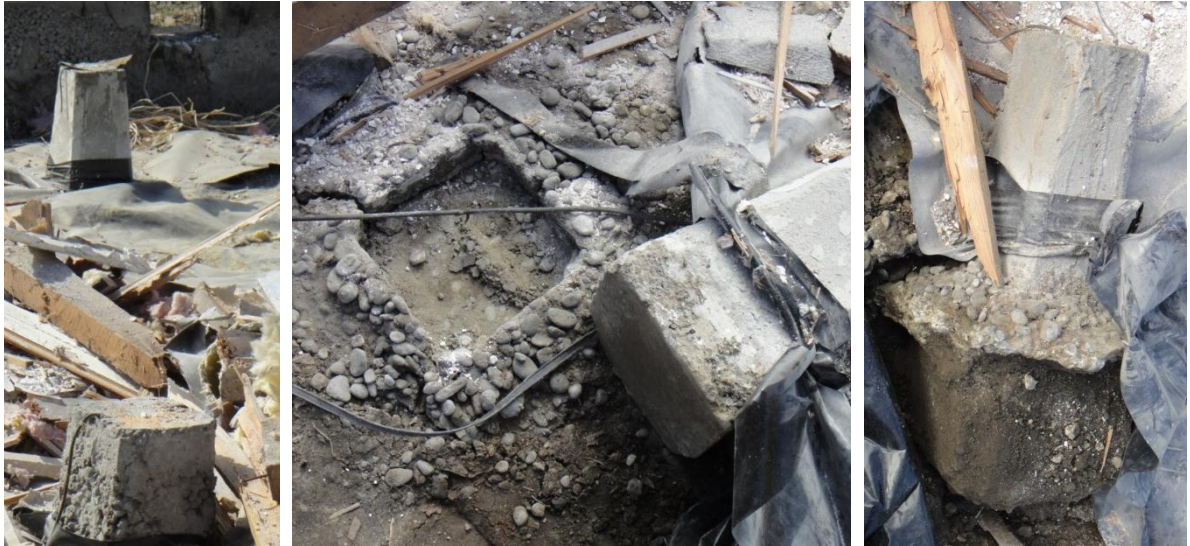
The piers were square, precast concrete. They measured 180x180mm at the bottom, and tapered to 140x140mm at the top. They were 450-600mm long and cast into the ground between 0-250mm. A number of piers were found to be sitting on top of their cast-in-place concrete footings, and were easily knocked out by the excavator (Figure 9).

Under the western half of the floor plan, none of the piers were tied to the sub-floor structure. The wire hooks were attached to the piers, but were not connected to the bearers (Figure 9). The eastern half of the piers were connected with wire hooks to the bearers above.

Figure 9. Pier details, (left) upright piers showing wire hooks bent down and not used, (centre) pier cast only level to the ground, easily knocked out and (right) pier cast more competently into the ground, still encased in footing.

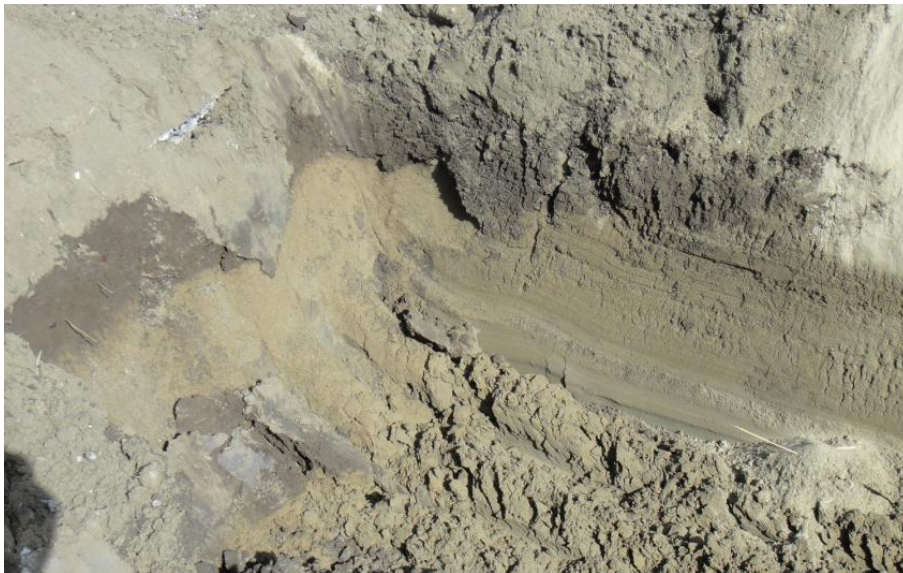
The ground under the house footprint consisted of a thin, 200-300mm layer of topsoil, which was underlain by quite clean, silty sand. Excavation was only carried out to ~700mm depth, so below this depth the ground conditions are unknown. Above the topsoil there was sand ejecta up to 300mm thick over the western half of the floor plan (Figure 10).

Figure 10. Ground conditions, showing thin layer of darker topsoil, underlain by clean brown silty sand.

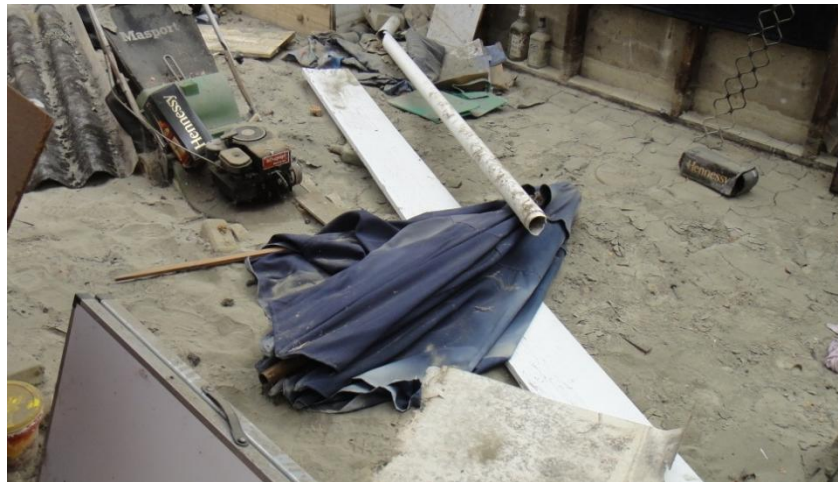
The garage floor was totally covered with dried cakey sand ejecta up to ~200mm thick (Figure 11).

Figure 11. P6: Liquefaction ejecta in the garage.

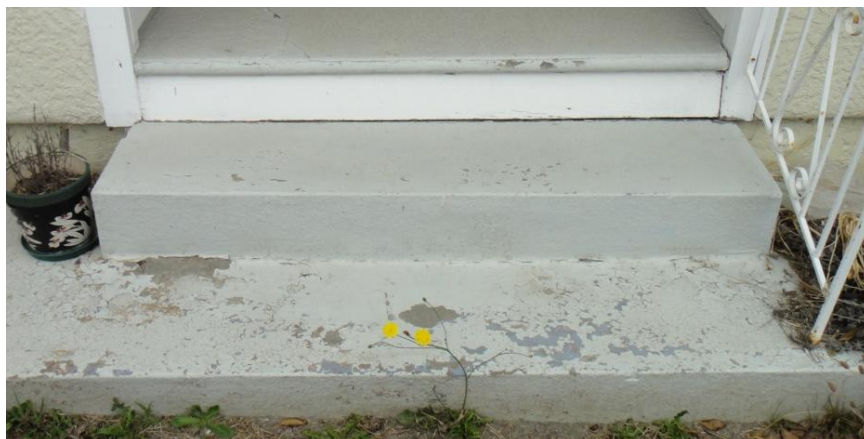
One set of steps on the North side was slightly separated (but still in tact) from the house by 5-10mm. It was also possible that the house has pulled away from the steps instead (Figure 12).

Figure 12. P7: Minor separation of concrete steps from house.

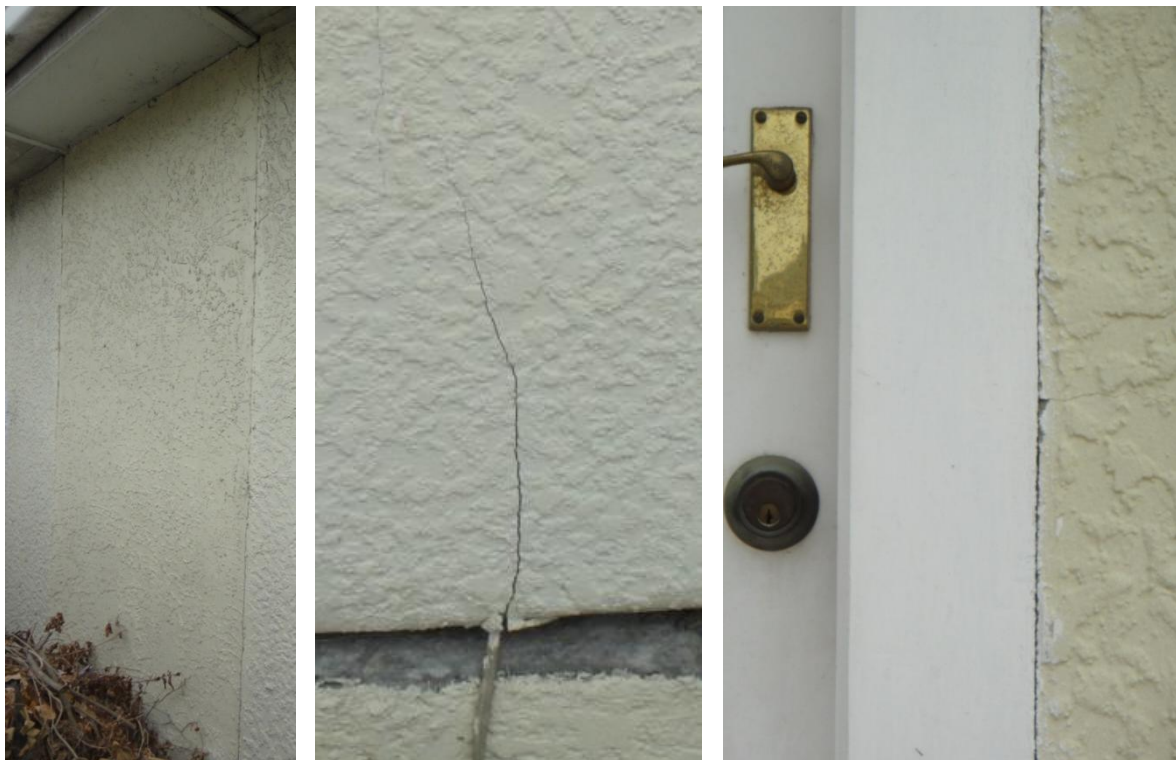
Structural damage to the cladding inside and out was generally low-moderate throughout the majority of the house. Most of the windows outside had hairline cracks in the stucco at their bottom corners. There were a few larger vertical cracks of 2-3mm width in the external cladding, some of which were flexural along the bottom of the North wall (P9) and two of which were along the joints between the old walls and a new wall where a fireplace had been (P8). There were also 0-1mm separations around the two door/entrance frames (P10).

Figure 13. Exterior structural damage, P8: Cracks along joints between old wall and new wall over large concrete footing (old fireplace). P9: Flexural crack in stucco. P10: 1mm separation around doorframe.

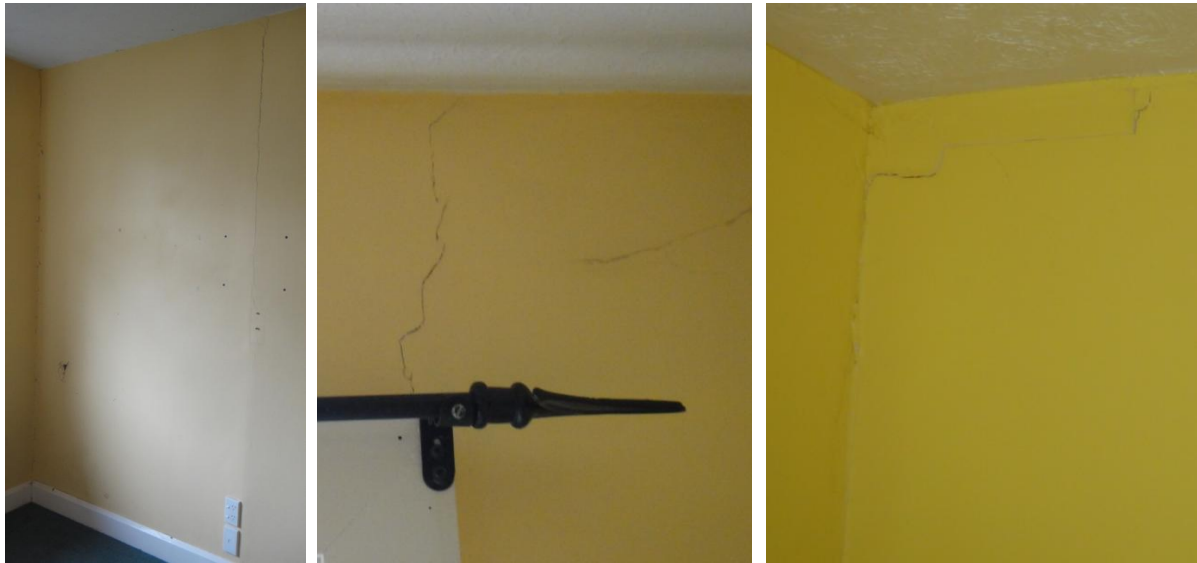
Damage to the interior cladding was generally low, with only minor hairline cracks in the plaster in most rooms above windows and doors. There were a few more significant cracks in plasterboard and at plaster joints in some places, mostly situated in the central bedroom on the South side (Figure 14).

P11 P12 P13
Figure 14. Interior structural damage. P11: Two floor-to-ceiling joint cracks in plasterboard. P12: More significant crack above window corner. P13: Minor crack at corner.

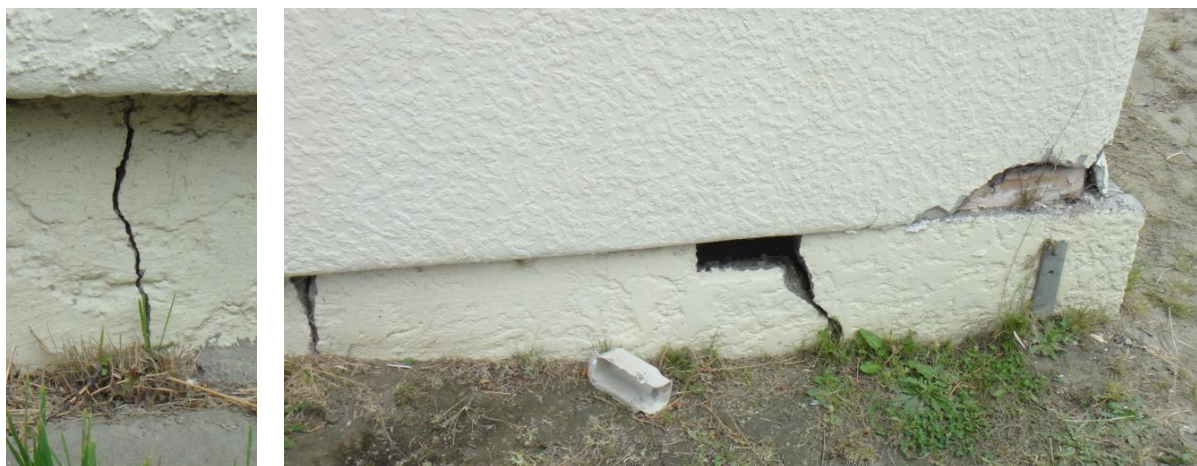
Foundation damage overall is high to severe throughout the building. There were a total of 24 cracks right around the perimeter, from hairline to 30mm width with 60mm horizontal offset. The majority of these cracks were 5mm wide or more. In both the East and West corners of the house, large sections (1m, 3m, 2m, 5m) of perimeter have broken completely from the rest and moved laterally out from under the building. In the case of the East corner, this section of perimeter has also settled more than the house above, causing significant structural damage (Figure 15).

P14 P15
Figure 15. Foundation damage, P14: low-moderate cracking in perimeter. P15: High-severe cracking and separation in perimeter.

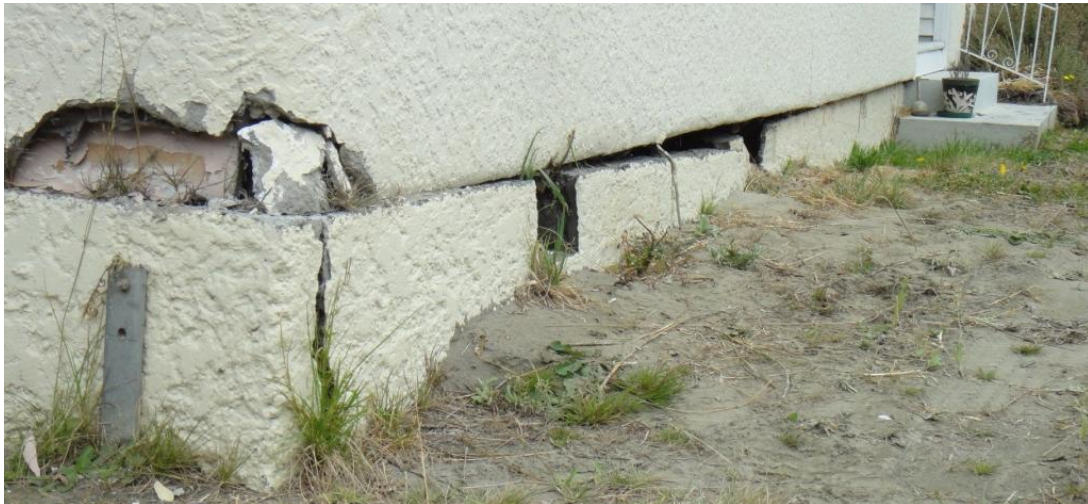
As a result of this extra settlement along ~10m of the wall, the superstructure appears to be pushing hard into the perimeter at both the East and South corners, causing spalling of the concrete perimeter and stucco wall (Figure 16 and Figure 18). At the West corner, there is a 30mm gap between the perimeter and wall, suggesting that here the house has lifted up off the perimeter, due to the overall differential settlement (Figure 17). This shows that the relatively weak perimeter broke up and settled in a very broken and differential manner, with the separated superstructure of the house remaining intact and tilting overall along the perimeter, causing the range of gaps between house and perimeter wall.

Figure 16. P16: East corner showing spalling of stucco with protruding perimeter and gap under wall extending to front-door stairs.

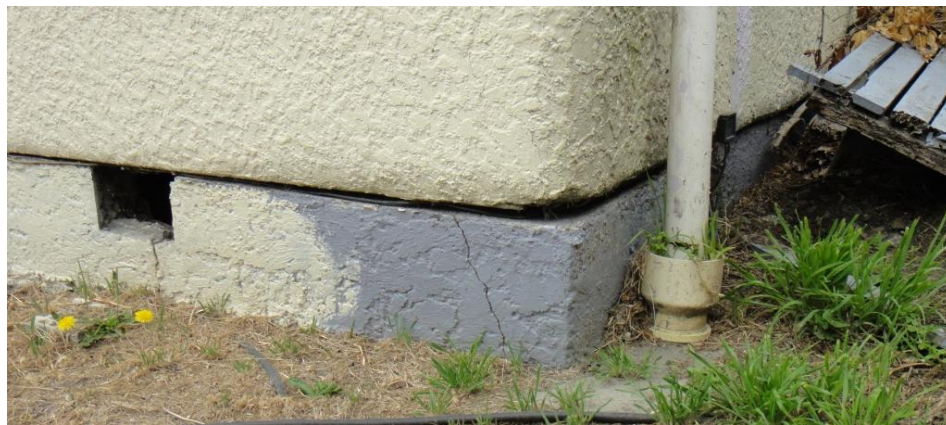
Figure 17. P17: West corner showing gap under wall and protrusion of perimeter.

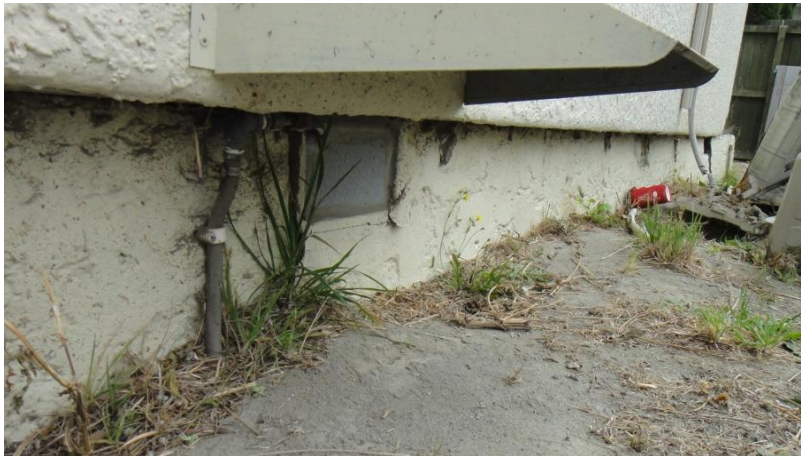
P18

Around the majority of the perimeter the building is protruding between 30 and 90mm over the concrete perimeter (Figure 18). It is assumed the house was built like this, although the large variation makes it difficult to tell. However, at the East and West corners of the house, sections of the perimeter wall are protruding from under the house. At the West corner (more minor) the corner has come out flush with the wall, suggesting a minimum of 30mm lateral movement (Figure 17). At the East corner, the perimeter is protruding by 40-60mm, suggesting an overall lateral movement of 70-150mm (Figure 16). From the East corner along the Northeast wall, the perimeter has also settled more than the house, from 0mm at the corner to 70mm lower 3m along the wall, leaving a gap under the wall. This gap closes up towards the front door steps (Figure 16). This long gap has caused the wall to sag, and produced at least 8 flexural cracks from the bottom of the wall, ranging from hairline to 2mm in width (Figure 13, P9).

Figure 18. P18: Southeast wall protruding over perimeter (like most of house).

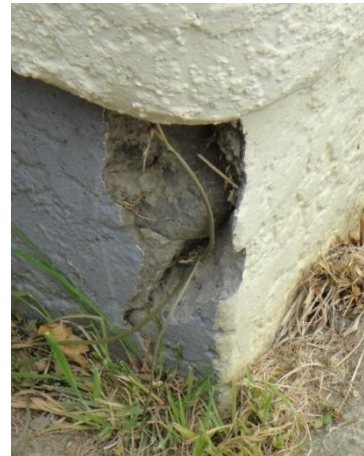
P19

Figure 19: South corner spalling in perimeter.

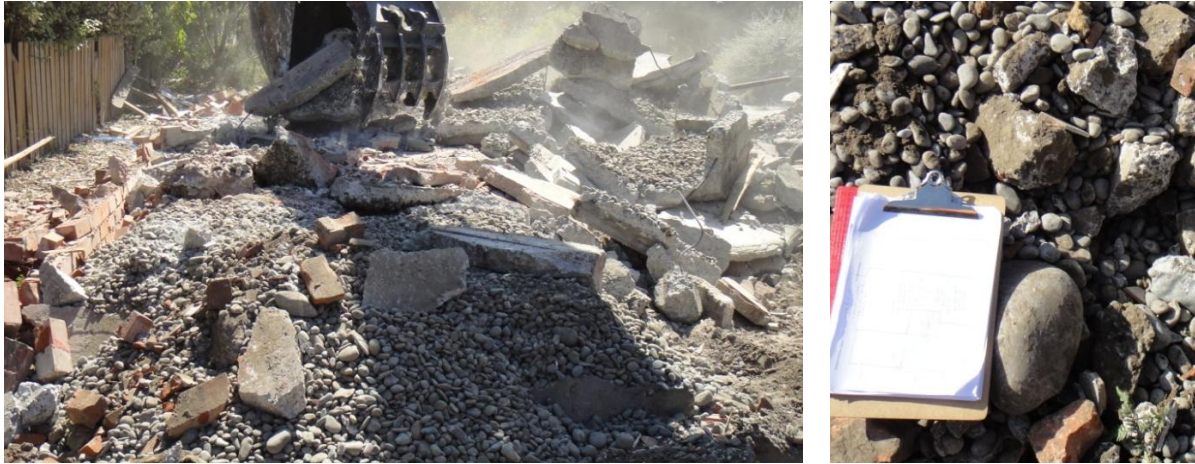
- Floor as a whole sits on top of bare ground (perimeter footings extend into ground around the outside by 200-300mm).
- The footings go up to the floor level. The space under the slab is filled with loose bricks (whole, broken and some plastered together) and tailings up to 200-300mm in diameter. The concrete was then poured on top of this, filling some of the voids between the loose fill, until the floor level was reached.
- The floor was built over some un-altered structures that were already present (i.e. old concrete stairs and patio area and brick foundation walls).

Figure 8. (left) high slab overlaying mixed fill, (right) size and material range of mixed fill.

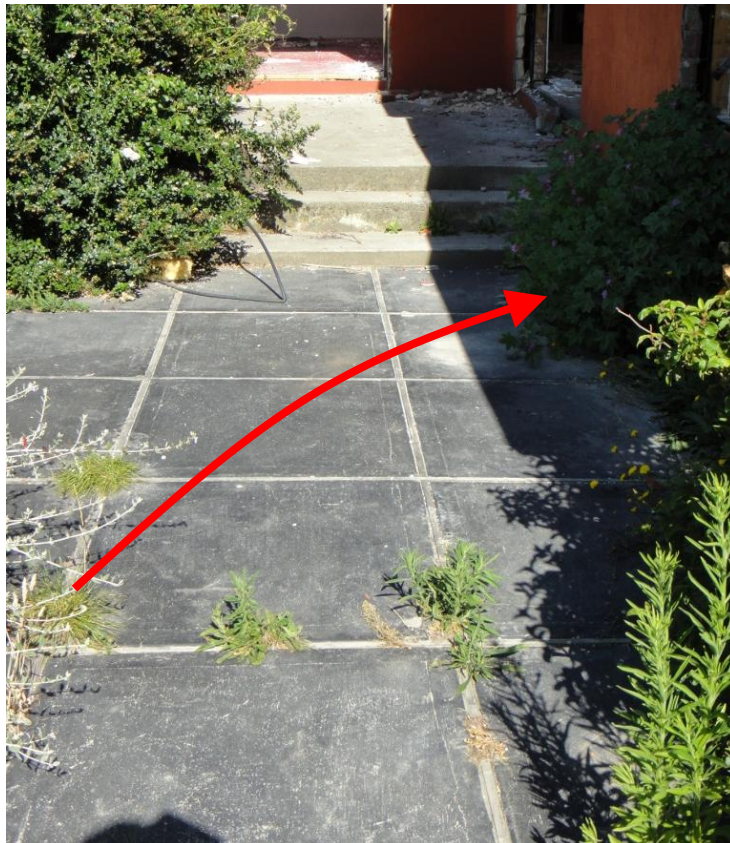
No retaining walls were present at the site. There was little cracking in the paving, but significant settlement in all. The concrete path along the back (Southwest side) of the house was tilting between 4.3-6.0° towards the house. Paving at the north corner of the house was tilting between 0.9-1.6°, with maximum settlement of 112mm towards the house (Figure 10). And concrete paving halfway along the Northeast side of the house was tilting between 0.5-1.5° to the south, with consistent settlement of 20mm towards the house, and 204mm overall differential settlement to the south. Neither of these two areas of paving were connected structurally to the slab foundations they were adjacent to. Much of the fencing was leaning and separating. There was some evidence of old liquefaction damage around the property, with some possible cracks and damage to the lawn. However this was quite overgrown and not obvious. No sand ejecta was present.

Figure 10. P4: North corner paving, showing direction of tilt in towards house.

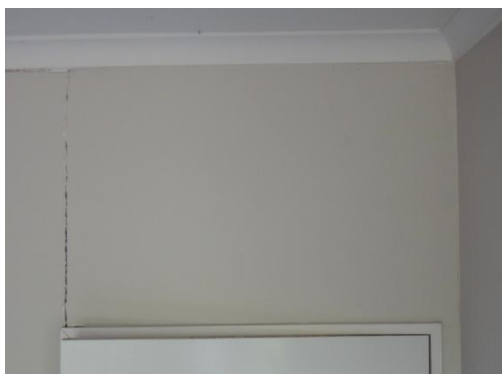
P5

Figure 11. P5: Vertical cracking above door frame. P6: Significant racking of door frame.

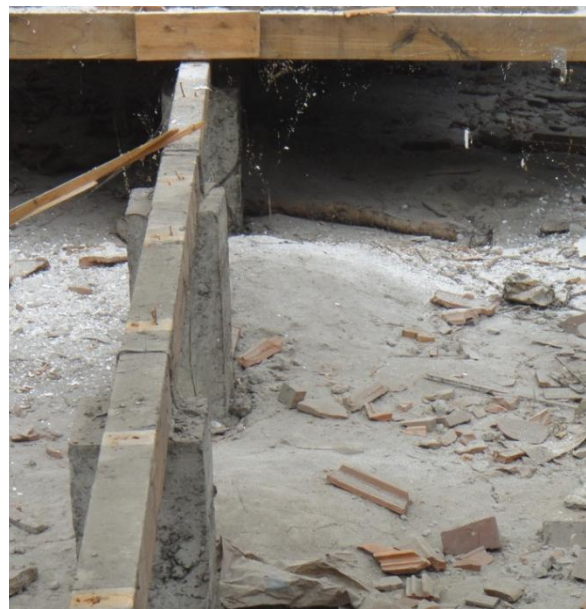
There was significant damage in the raised-floor part of the house. The perimeter part of this area had floor humping in most rooms, shown by the differences in slope angles measured. This was found to be caused by sand ejecta around the piers supporting these floors, which caused pushing up and sinking of the piers. The floor and pier structure was unconnected to the brick perimeter and wall part of the house, which caused interior separation between the walls and floor of 10-20mm in the E corner of the perimeter section, as the floor sank and the walls moved independently of this. There were three significant cracks in the tiling of the raised floor, two along the edges of the raised slab, caused by a difference in slope in the perimeter, pier-supported and slab-supported parts of the floor, and one between two sections of the raised slab, which were separated by a continued brick foundation wall extending through the slab from the perimeter section.

Figure 13. P14: Sand boils around piles causing humping of floor.

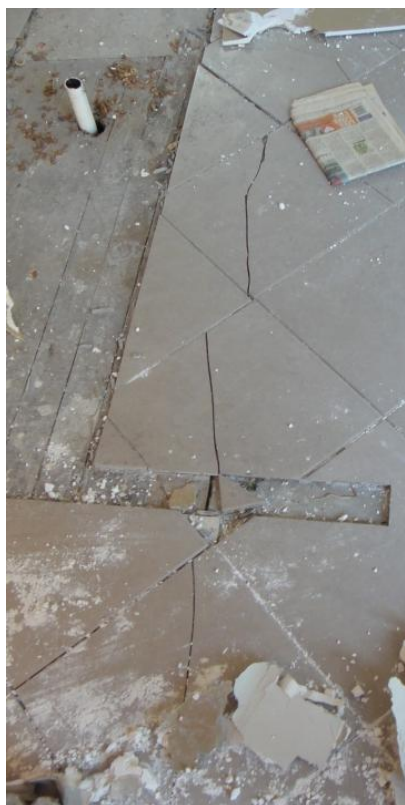
P15

Figure 14. P15: Crack in floor tiles along slab joint. P16: Separation between timber floor and wall (NE side). P17: Separation between floor and wall (SW side)

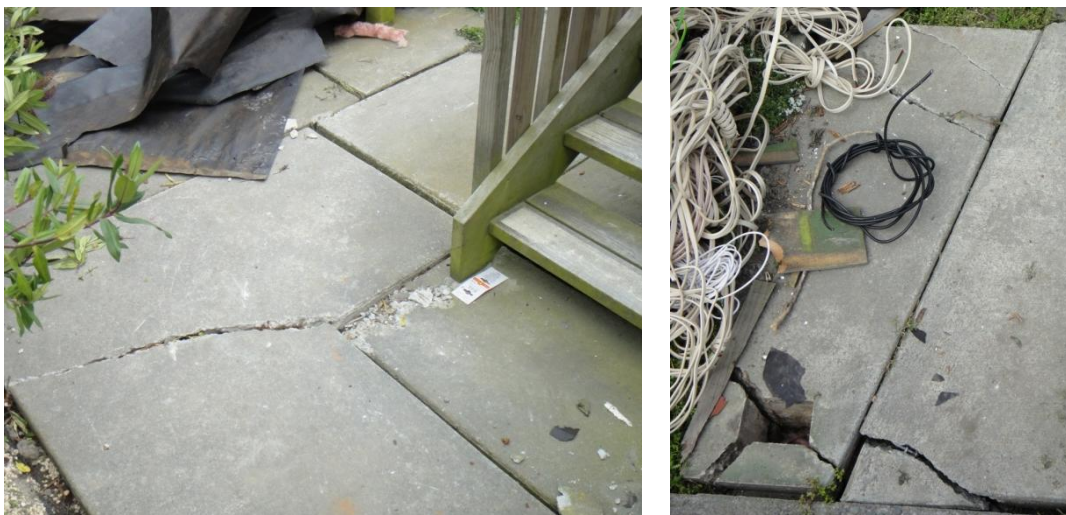
No decks, steps or retaining walls were present at the site. All concrete paving was severely damaged, with most of the paving cracked and separating by up to 50-70mm (Figure 6). Tilting and settlement of the pavement was also high. There was little to no damage to fences.

Figure 6. Cracking and separation in the paving around the house, P3 (left) and P4 (right).

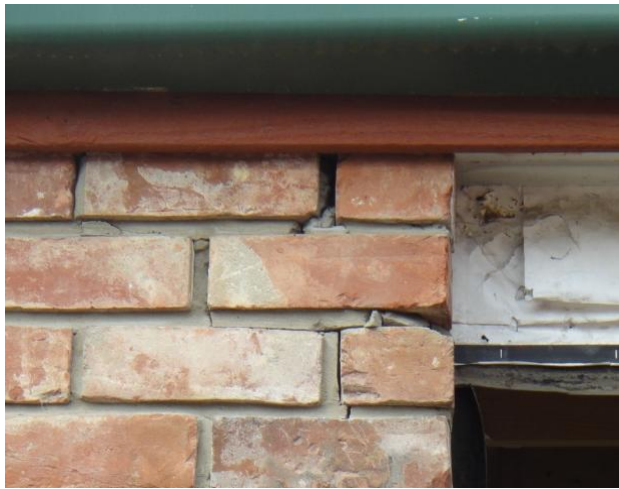
P5

The external cladding also suffered only minor damage. There was only minor cracking at window corners in the external brickwork (Figure 7).

Figure 7. Damage to the external brickwork, showing minor cracking at window corners.

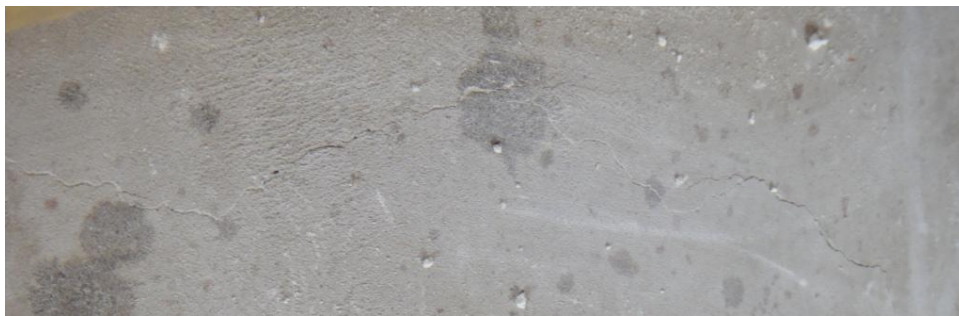
Visible damage to the exposed floor slab was low. There was only one minor crack in the slab, around 0-1mm wide and 3-4m long running E-W along the slab in the middle of the North side of the house (Figure 8). Tilting of the slab was high, between 48-102mm across the building, sloping down to the North. The North half of the house was more severely tilted, with slopes between 0.5°-1.7° to the North, compared to the South half of the house with slopes between 0.1°-0.3° to the North. This indicates hogging along an E-W line somewhere around the middle of the house, and is assumed to be the reason for the crack in the floor slab. This crack was also situated at a change in plan from 2-storeys to 1-storey in height.

Figure 8. P9: Crack in concrete slab.

The building had an overall differential settlement of 48-102mm from the South side down towards the North. The 1-storey section of the building on the North side settled slightly more than the rest of the building, causing low-moderate hogging of the overall structure. This was indicated by different slopes in the floor between 1 and 2 storey sections, and the minor crack in the slab.

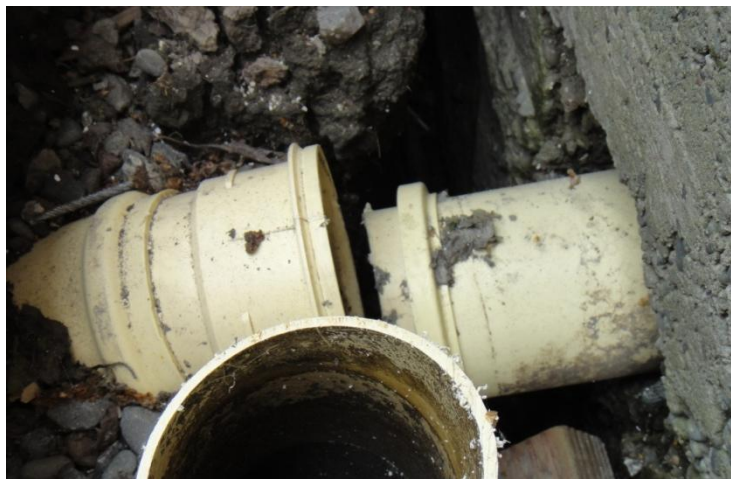
The building had an overall global settlement of 60-70mm on the South side of the house (the high side), which was shown by a vertical offset between a sewerage pipe entering the slab (Figure 10). Adjusting for the tilt of the house, this corresponds to an overall global settlement of 110-120mm.

Figure 10. P11: Vertical offset of sewerage pipe between ground (left) and house (right).

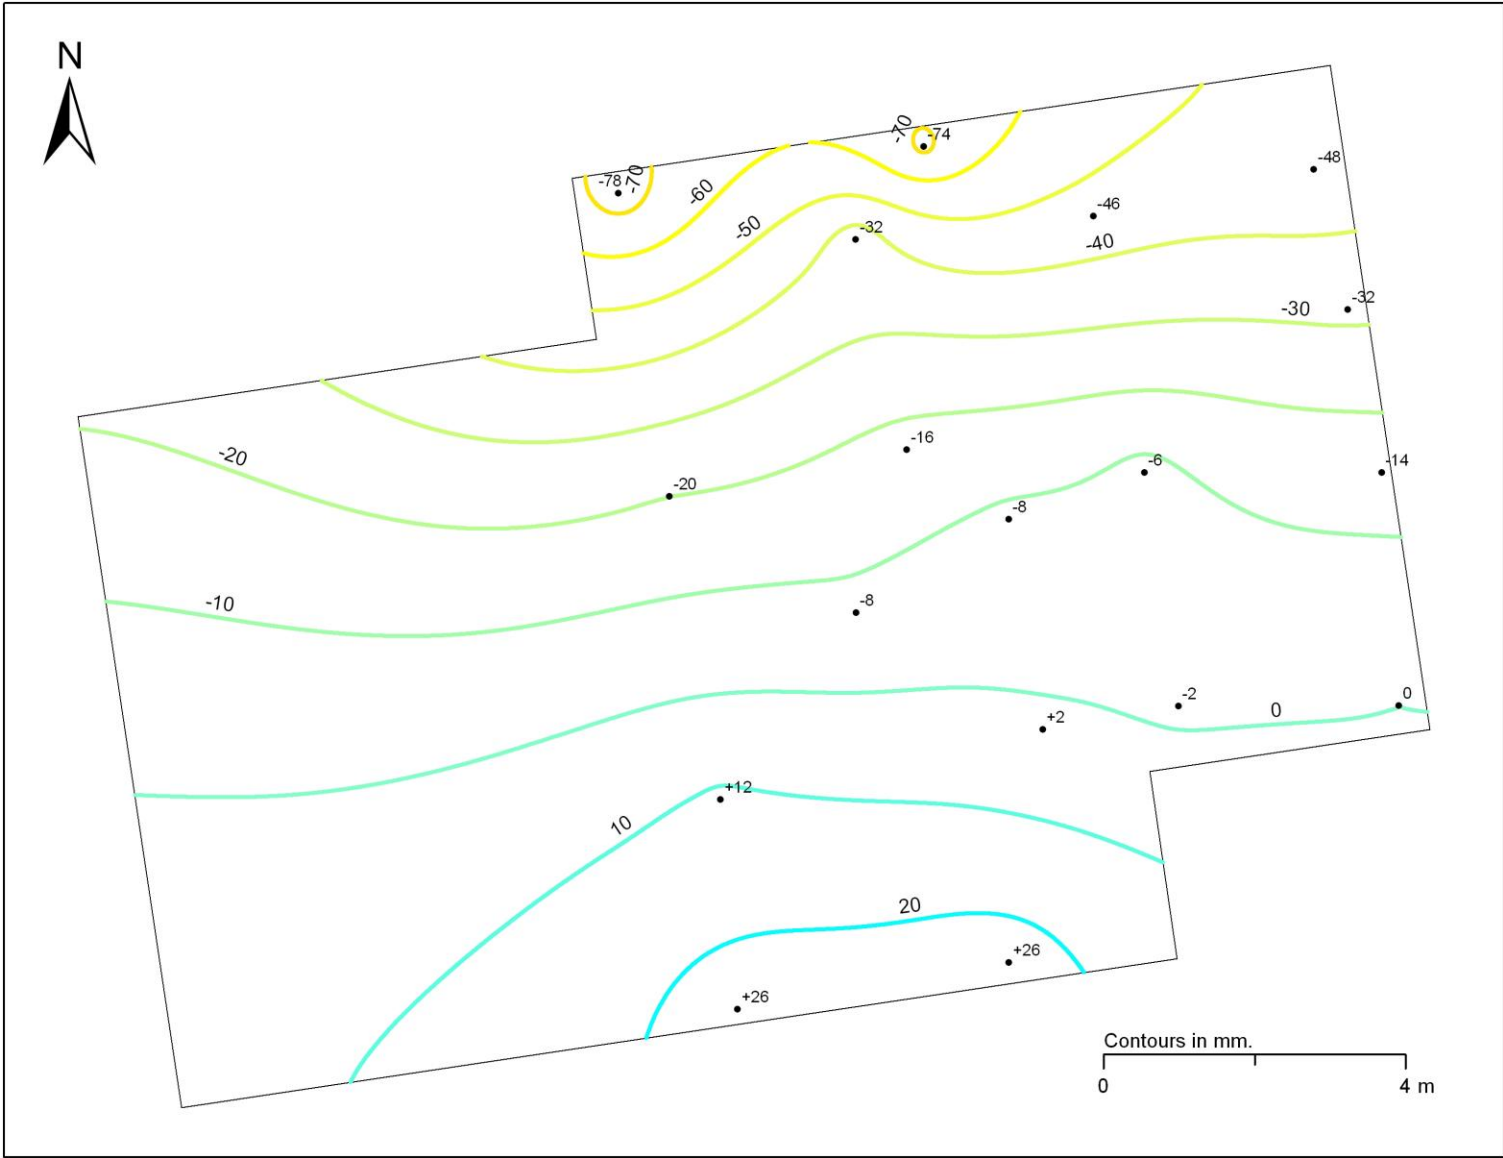
Figure 11. Floor plan showing floor levels and contours.

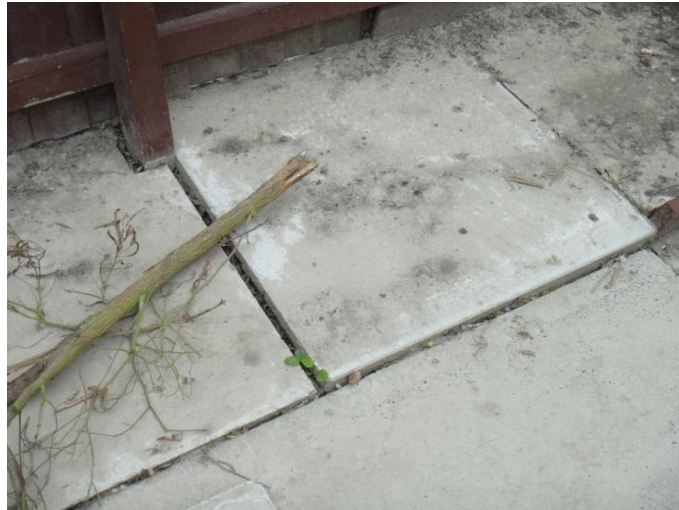
No decks, steps or retaining walls were present at the site. Concrete paving was severely damaged, with most of the paving cracked and separated, with significant heaving and settlement (Figure 5 and Figure 6). There was little to no damage to fences.

Figure 5. P3: Separation of concrete paving.

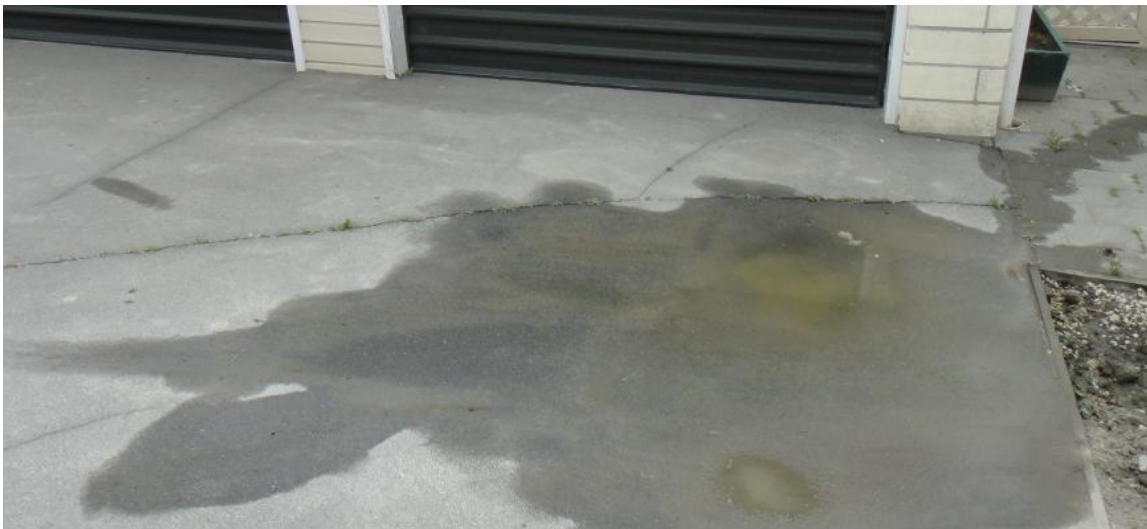
Figure 6. P4: Cracking in asphalt paving.

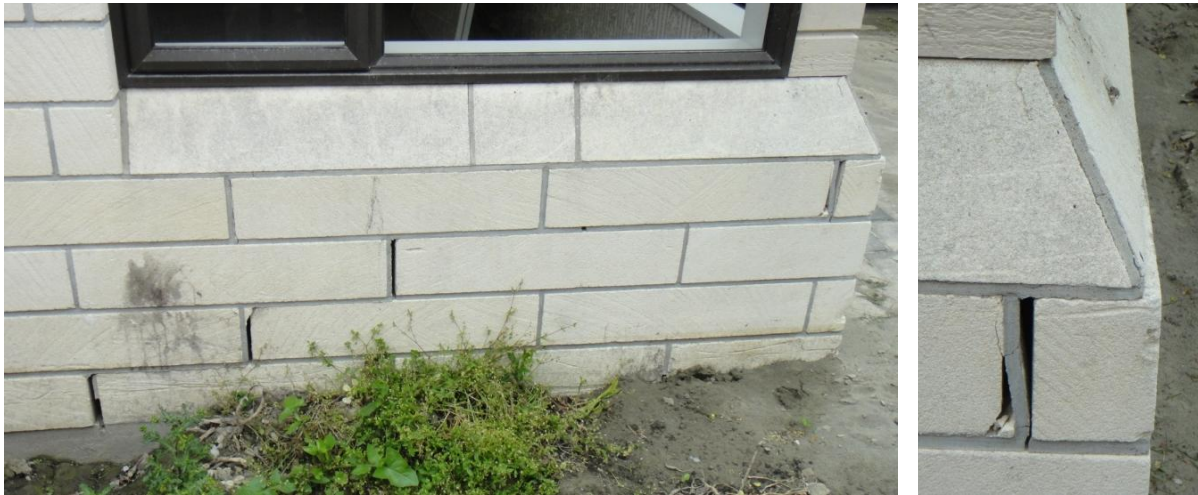
There were low levels of damage to the external cladding, with some smaller cracks in the brick cladding and a couple of places where the corner bricks at ground level were falling off (Figure 7). The interior also suffered relatively minor damage, with some small vertical cracks above doors and windows and a few in corners (Figure 8). Despite the low level of damage to the cladding, there was significant structural damage overall, as most doors and windows were sticking, including both garage doors which were jammed and would not open.

Figure 7. P5: Cracking and separation of bricks at corner of house, overall (left) and close-up (right).

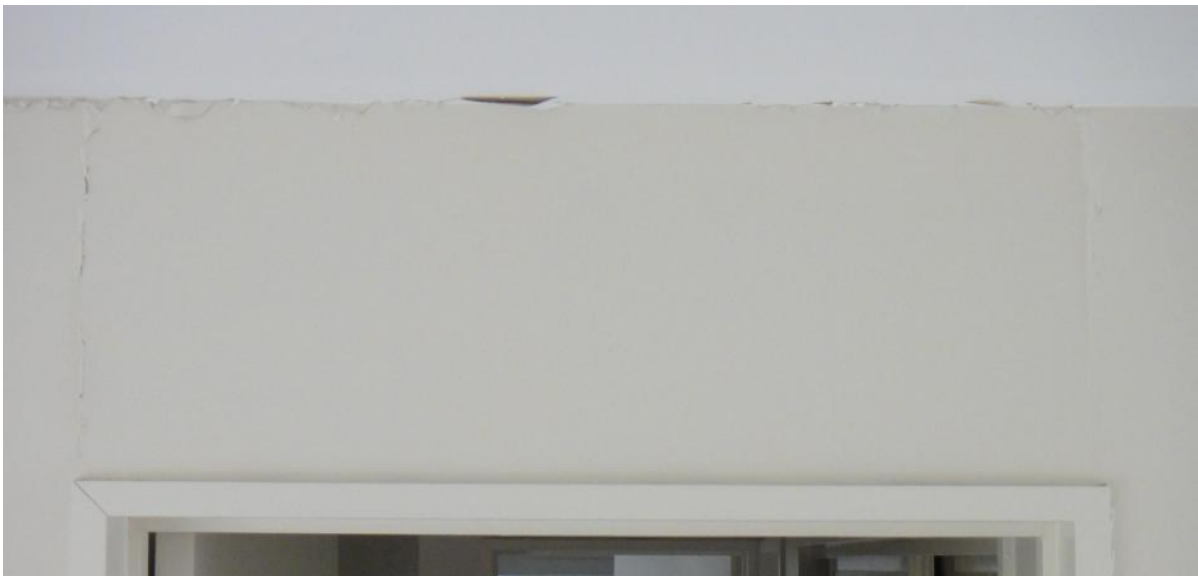
Figure 8. P6: Minor vertical cracking above door frame and at wall/ceiling interface in interior plasterboard.

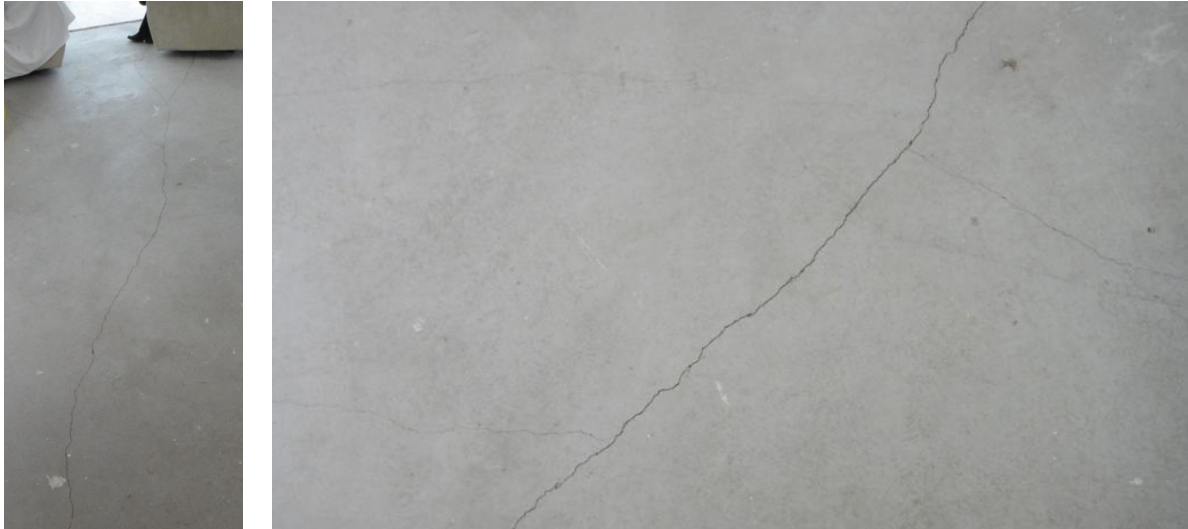
There was extensive minor cracking right across the foundation slab. Cracks were between 0-2mm wide and 2-5m long in multiple directions and intersecting with each other (Figure 9). There was extensive settlement and tilting of the house, with up to 180mm differential settlement over the length of the house. The foundation in the North wing of the house suffered some hogging damage in the N-S direction, with local differential tilting in other parts of the foundation. Floor slopes up to 1.0° were found. The extreme tilting and extensive differential slopes of the foundation are assumed to be due to the severe liquefaction suffered and the weak construction of the foundation with round aggregate.

Figure 9. Minor cracking in concrete floor slab, P7 (left) and P8 (right)

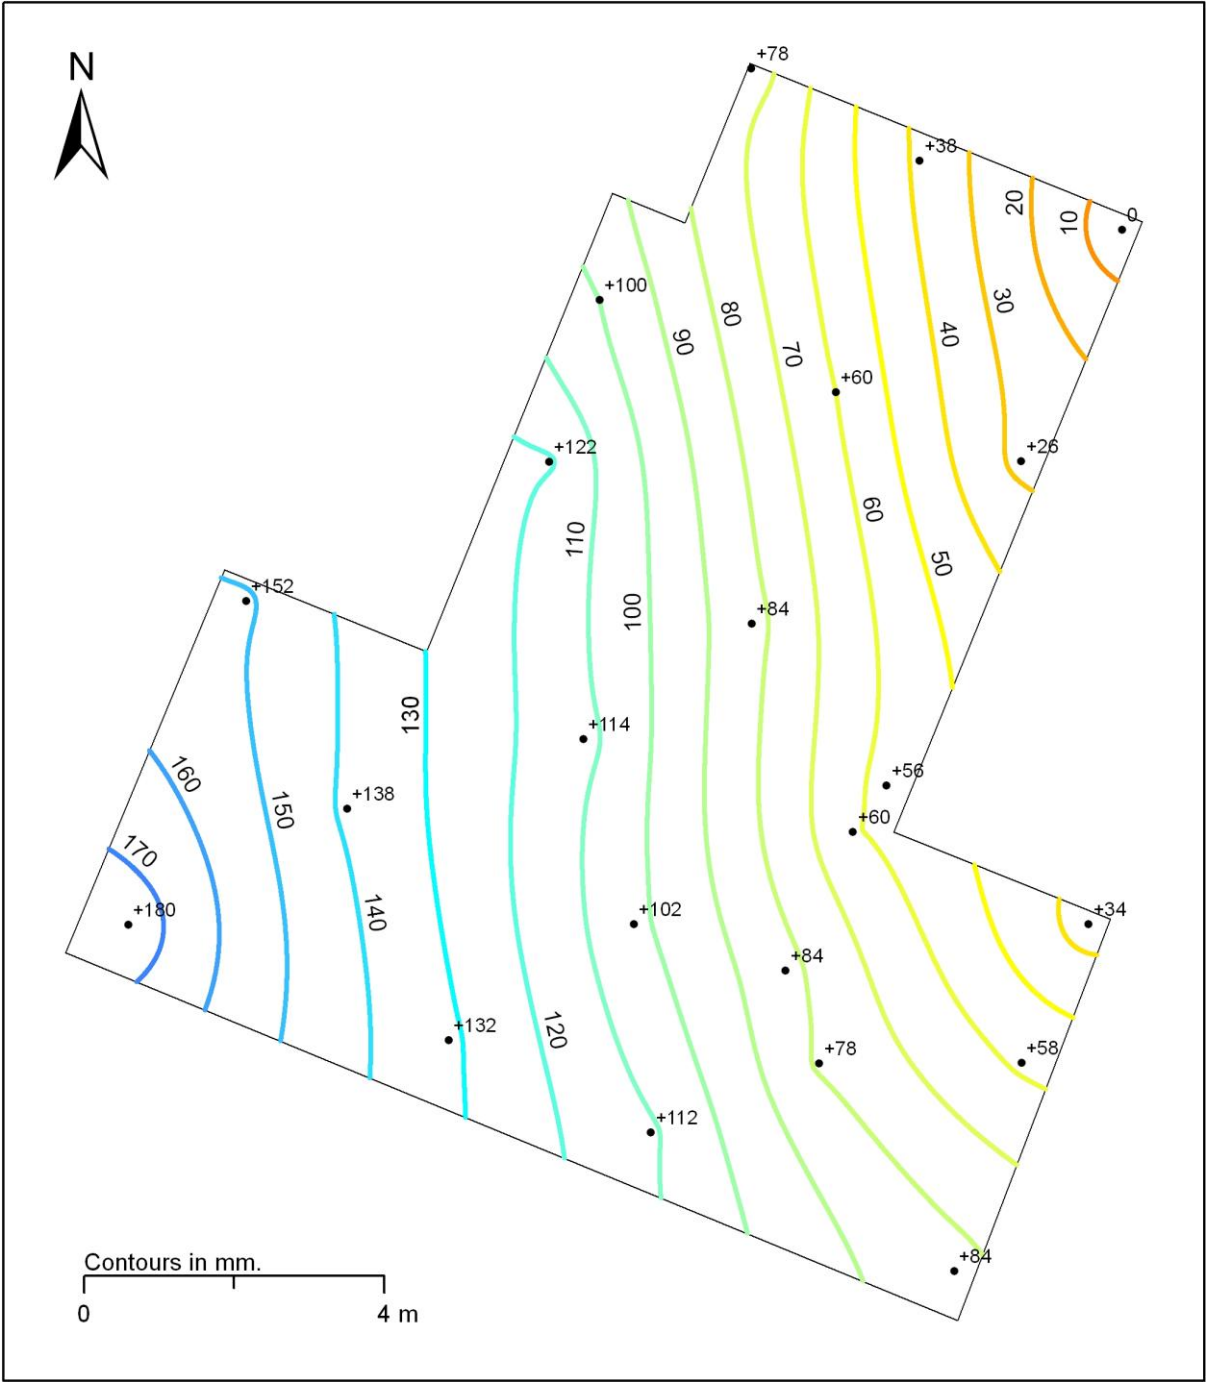
The building had overall global settlement of 130-170mm, which was measured from the sloping lawn that was once flat (after discussion with the owners). In addition, the whole house is tilting differentially between 74mm and 118mm to the East. The North part of the house is also hogging in the N-S direction, and the south part of the house is tilting quite uniformly towards the north part of the house by up to 0.7°. Despite the large movement of the structure, damage to the superstructure is relatively minor, suggesting the construction of the superstructure was very competent. The house is located in the centre of a large (approximately 350m diameter) semi-circular bend in the nearby river Avon, so did not experience a large degree of lateral spreading under the footprint of the house, although significant lateral spreading did occur in all directions closer to the river. However, the severe liquefaction under the house and the weak construction of the foundation caused the large structural damage and overall settlement of the building.

Figure 10. Floor plan showing floor levels and contours.

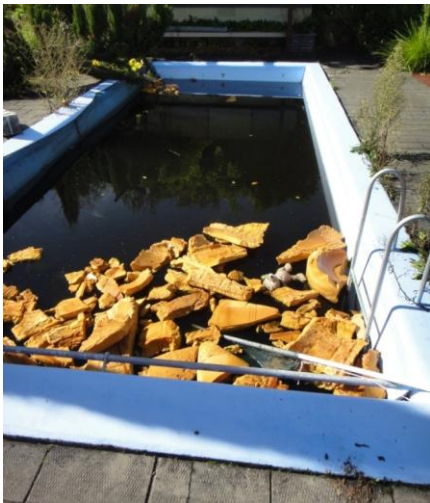
P4

There was moderate damage to the surrounding property. Decks showed some low tilting and separation, though this may have been due to age rather than the earthquake. Fences were tilting in a few places. Concrete paving was cracked in most locations, along joints in the concrete. With separation up to 20mm between sections. The pool was tilting 0.5-0.7° to the N and separated from the surrounding paving by 10-20mm in some places.

Figure 10. Damage to surroundings. P4: Pool area tilting to N (left). P5: Separation in paving around pool. P6: Cracking and separation in paving.

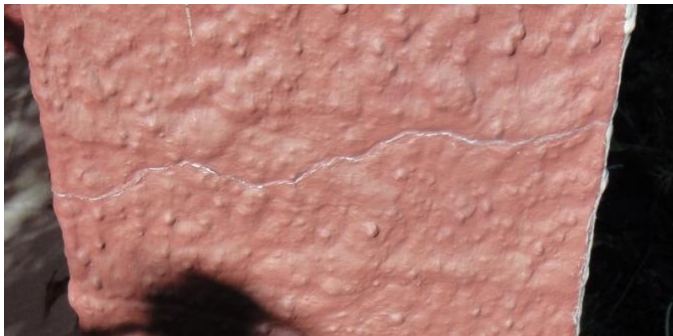
P7

Overall the structural damage to the house was very low. There were three hairline cracks in the external stucco cladding. In the interior there were two areas of significant cracking identified. The concrete wall behind where the fridge was in the kitchen had numerous horizontal, vertical and diagonal cracks from 0-2mm wide. The wall in one of the bedroom cupboards also had a 1-2mm diagonal crack. There was cracking in the plaster ceilings in every room in the house from 0-2mm wide running all ways. Except the kitchen which had a standard plasterboard ceiling.

Figure 11. Structural damage. P7: Hairline crack in stucco cladding. P8: Cracking in bedroom cupboard. P9: Cracking in concrete wall behind fridge. P10: Cracking in plaster ceiling.
